Subject: Department of Natural Resources Washington Geological Survey,
School Seismic Safety Assessment Project, Contract No. AE 410 -
Seismic Evaluation for **Royal School District**

School Buildings Evaluated in the Royal School District

1. Red Rock Elementary School, Main Building
2. Royal High School, A Gymnasium
3. Royal High School, B Main Building
4. Royal Middle School, Main Building

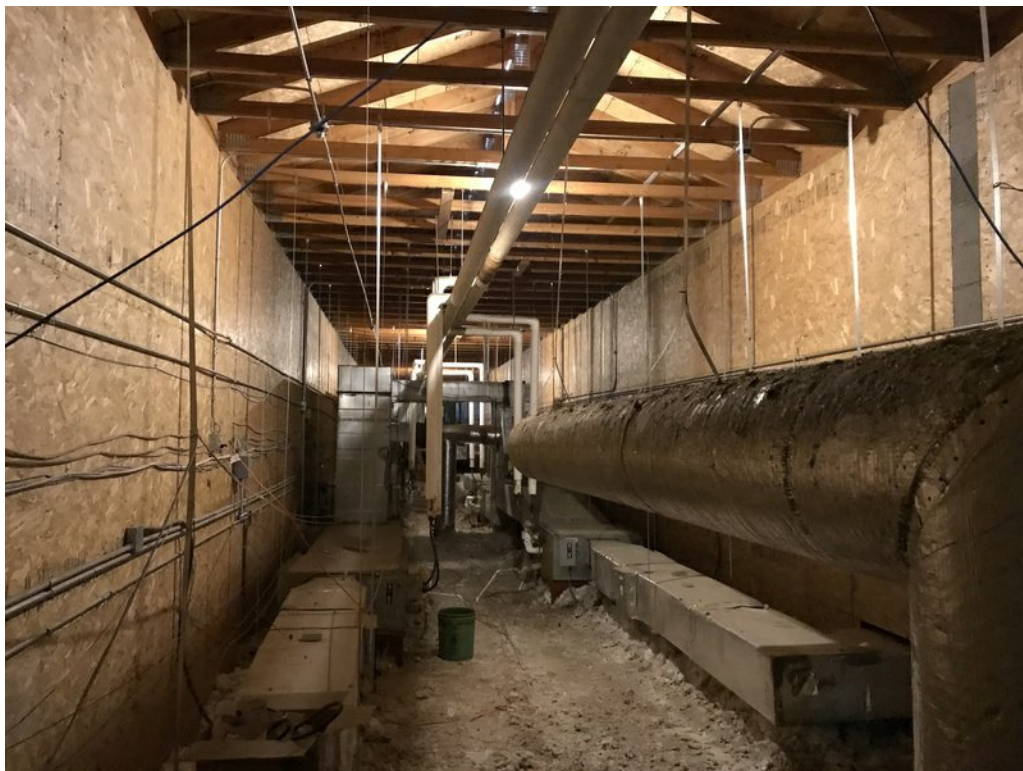
Figure 1-2. Mechanical attic with duct work and piping visible.

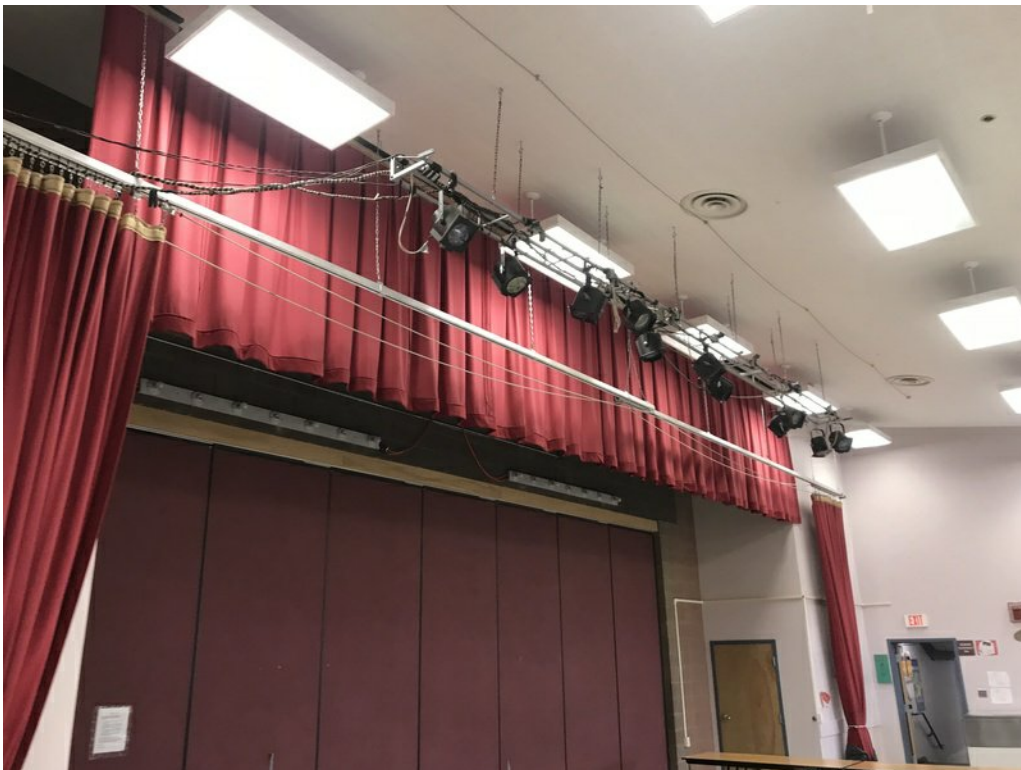
Figure 1-6. Lighting and rigging in the cafeteria/multipurpose room.

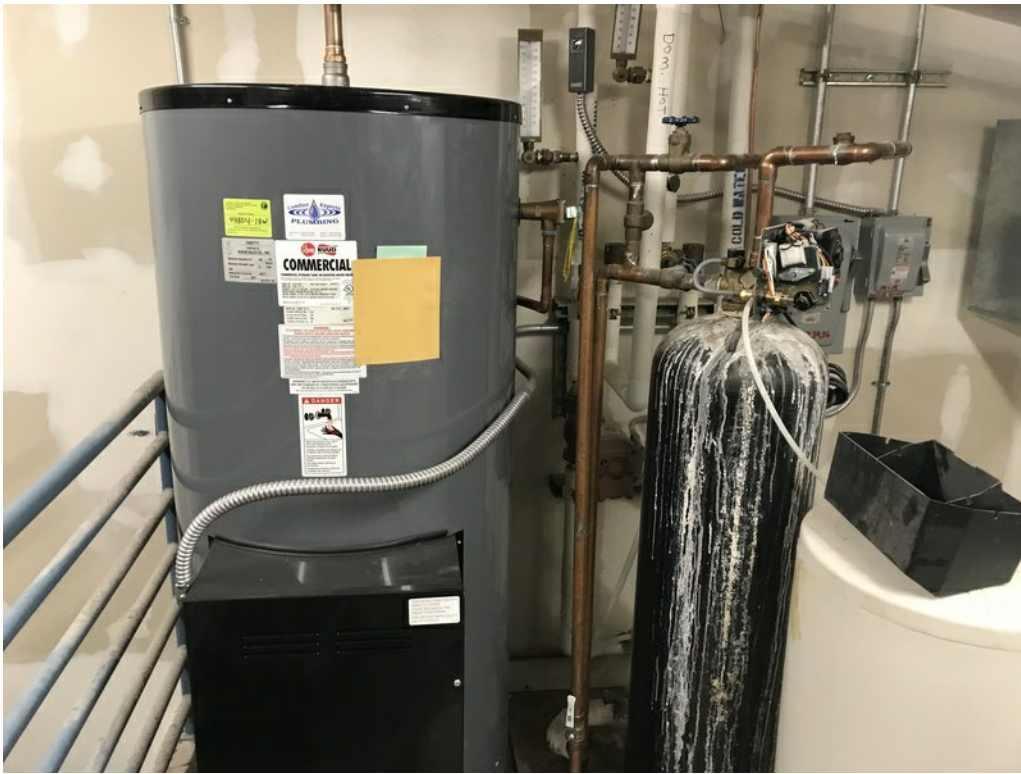
Deficiency	Description
LSS-1 Fire Suppression Piping. HR-not required; LS-LMH; PR-LMH.	No bracing was present in the visible areas of the system.
ME-2 In-Line Equipment. HR-not required; LS-H; PR-H.	No bracing was seen in the mechanical room.
ME-3 Tall Narrow Equipment. HR-not required; LS-H; PR-MH.	The water heater was not strapped back or braced. No bracing was seen in the mechanical room.

Figure 1-7. Water heater with no visible lateral bracing.

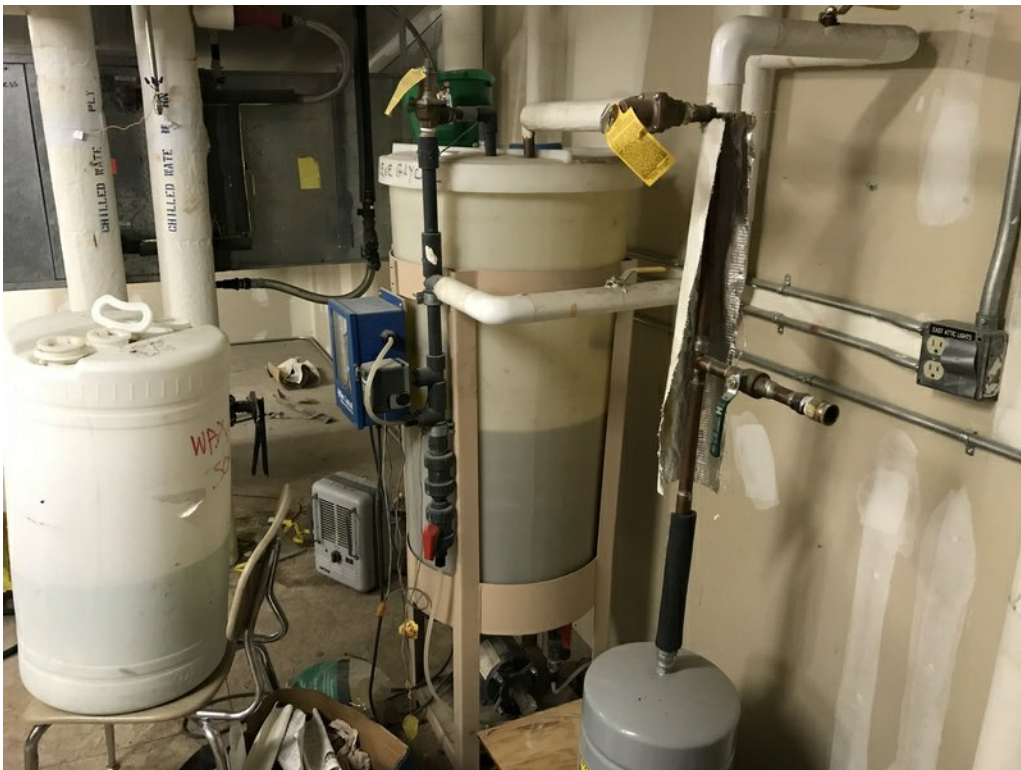
Figure 1-8. Glycol tank with unknown lateral bracing.

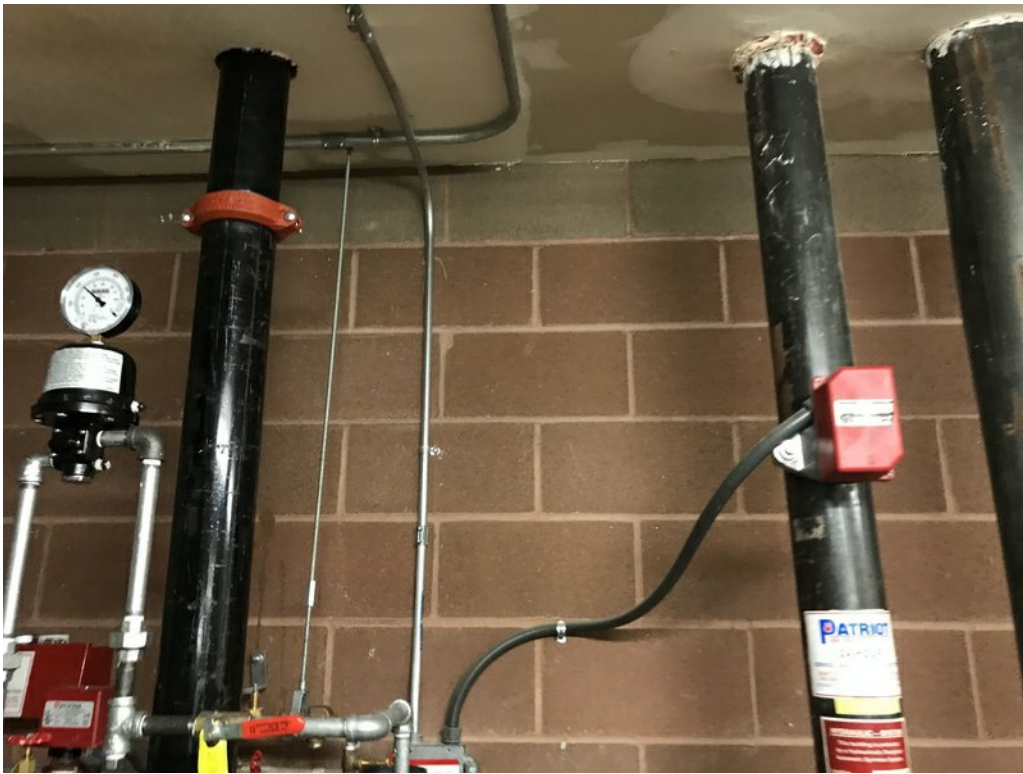
Figure 1-9. Fire riser equipment.

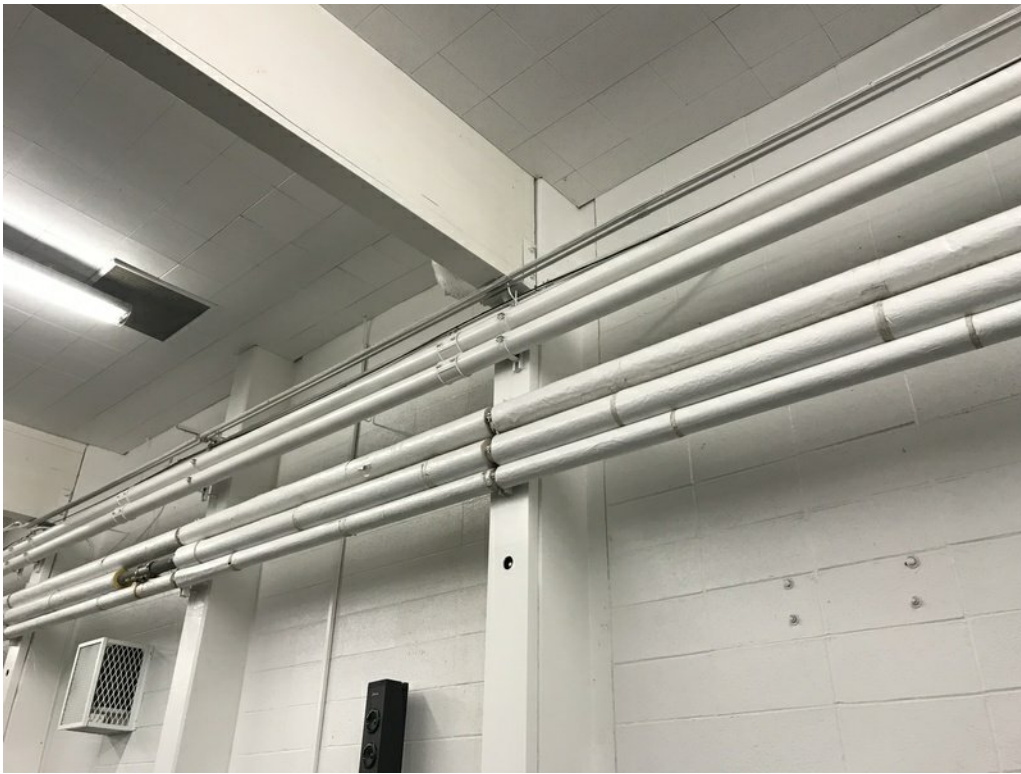
Figure 1-9. Piping anchored to wall.

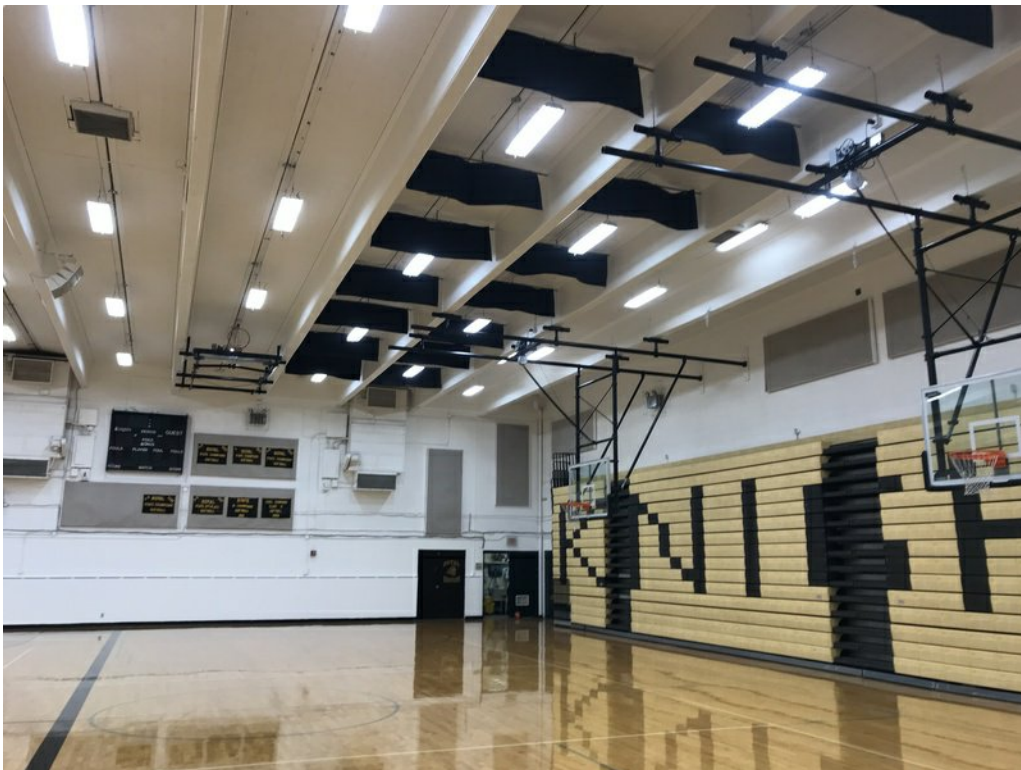
Figure 1-10. Gymnasium with large mechanical unit mounted on wall.

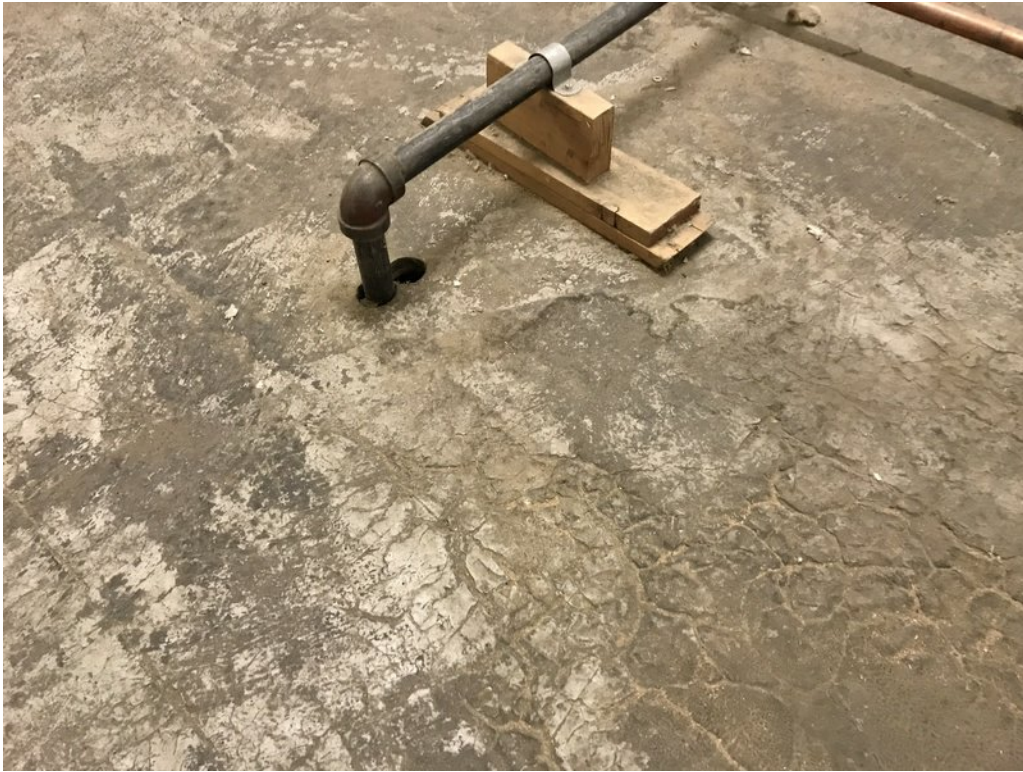
Figure 1-3. Pipe penetrating slab-on-grade.

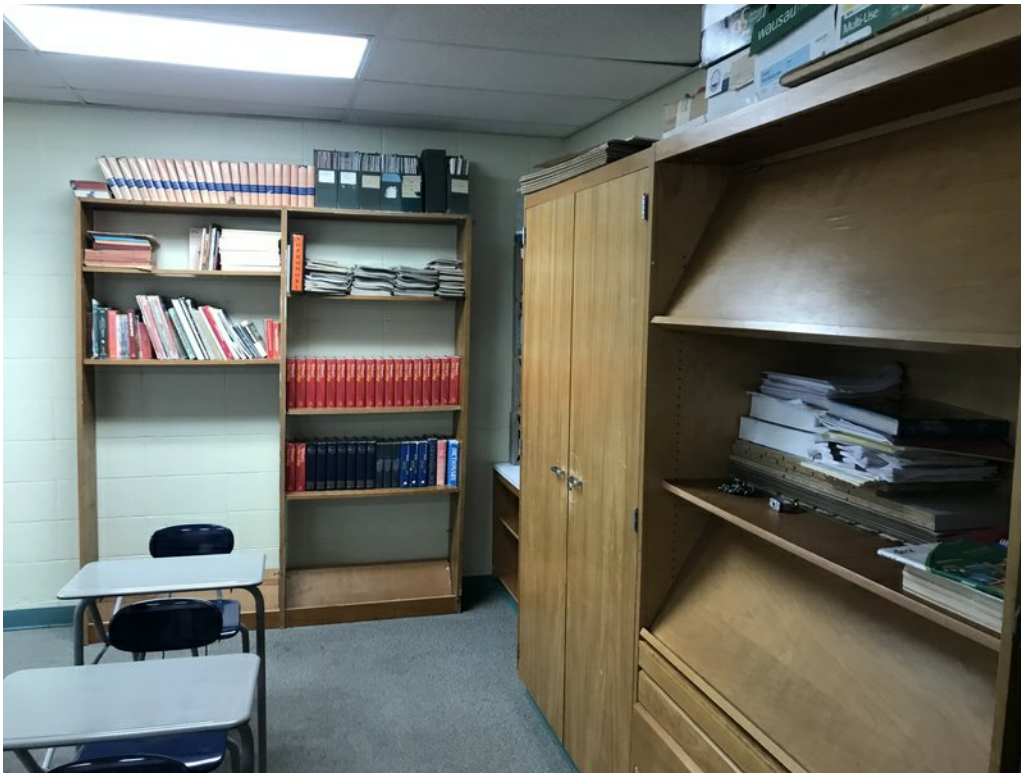
Figure 1-5. Shelving and storage cabinets in a classroom.

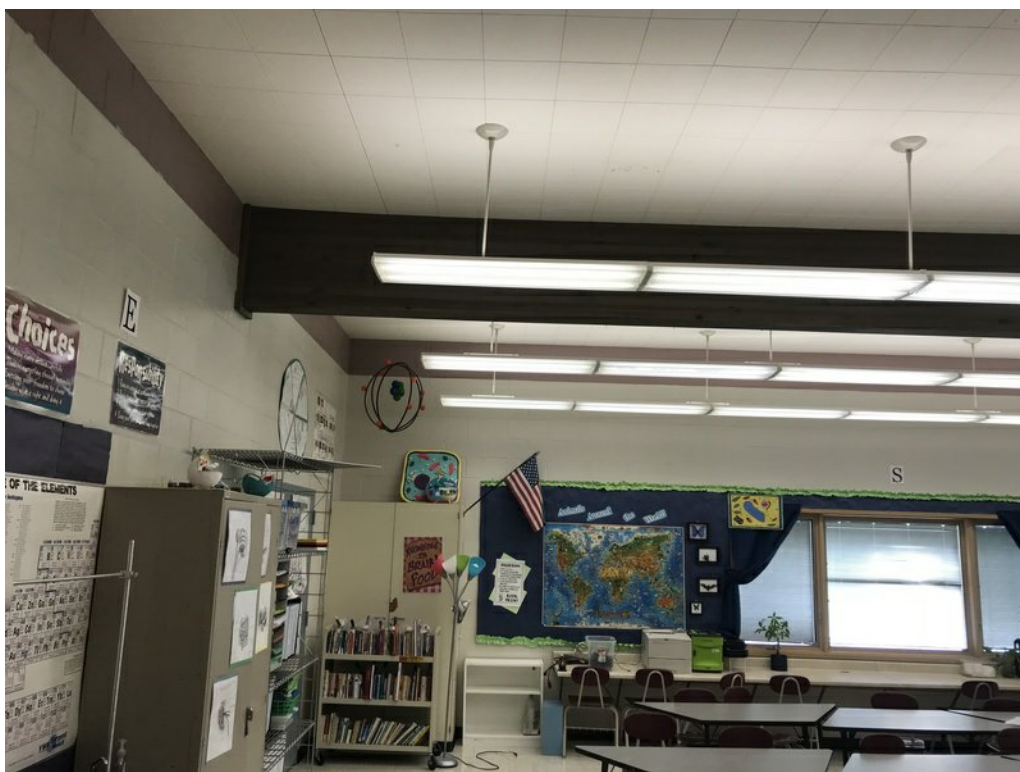
Figure 1-6. Classroom with tall storage cabinets.
